# Multi-Purpose, Flexible Repair Composite

**BELZONA®**  
**2211**

Belzona 2211 (MP Hi-Build Elastomer) is a two-component paste grade elastomeric repair composite for the repairing and rebuilding of rubber components.

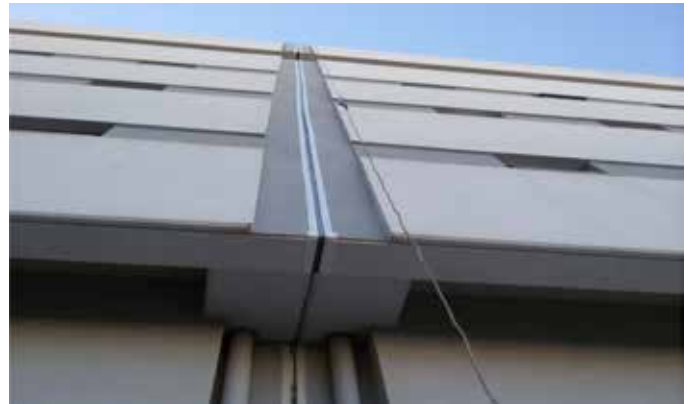
BEFORE

AFTER

Damaged part rebuilt

Crack and rip repaired

New component cast

Dissimilar material sealed
