# Industrial Coating for the Protection of Floor Areas

Belzona 5231 (SG Laminate) is a two-component, liquid-applied coating system, designed for floor areas where chemical, abrasion and slip resistance are required.

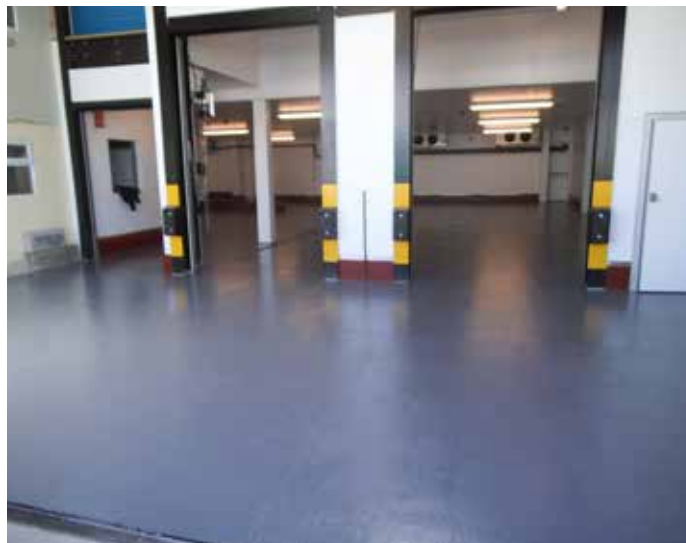
Dairy warehouse floor restored with Belzona 5231

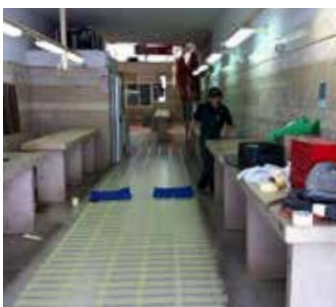
Tiled floor before

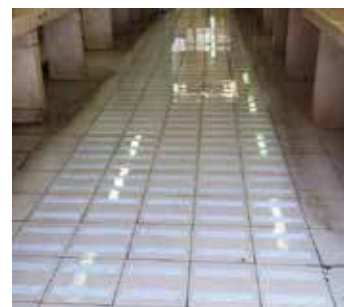
Tiled floor after
